## WINGRAVE METHODIST CHURCH

### STAGE 1 CLOSURE REPORT: 20 DECEMBER 2013

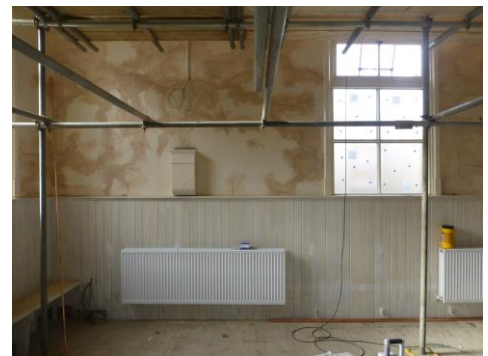
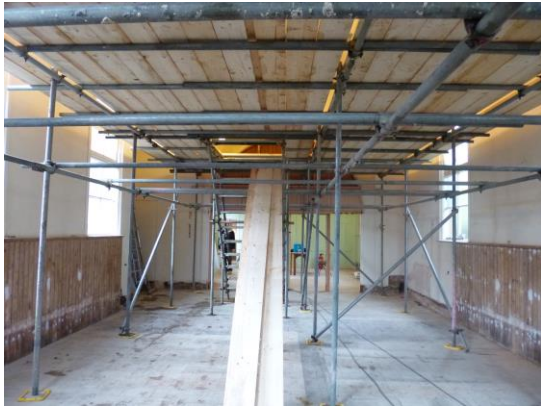
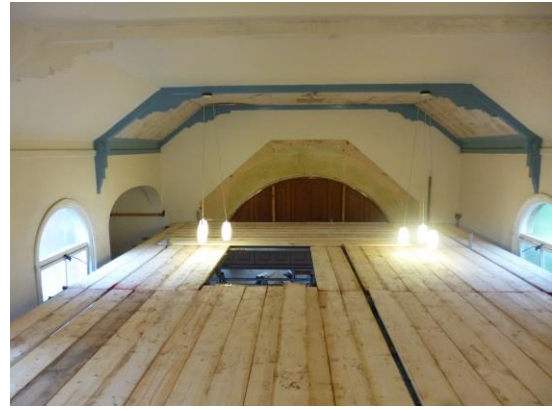
The first areas of work were the installation of the new central heating and electrical systems and a start on making good the wooden panelling, walls and ceiling. However it was soon found that the condition of the walls was poor and that the ceiling was in a dangerous state. It was decided to reinforce and make good the ceiling prior to redecoration – an activity which was not included in the original project plan. This work required the construction of a scaffolding platform within the building – again something which was not envisaged in the original plan.

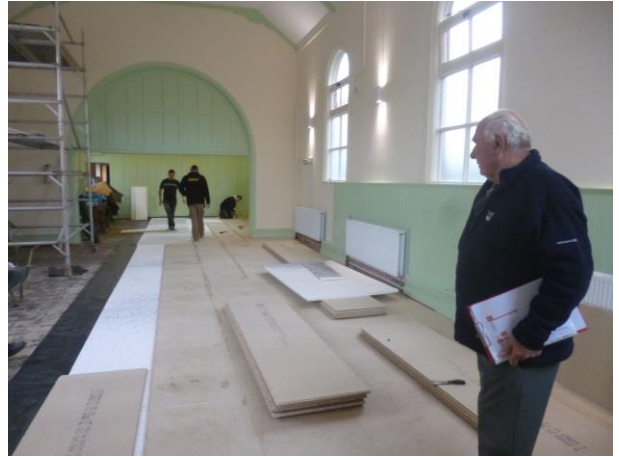
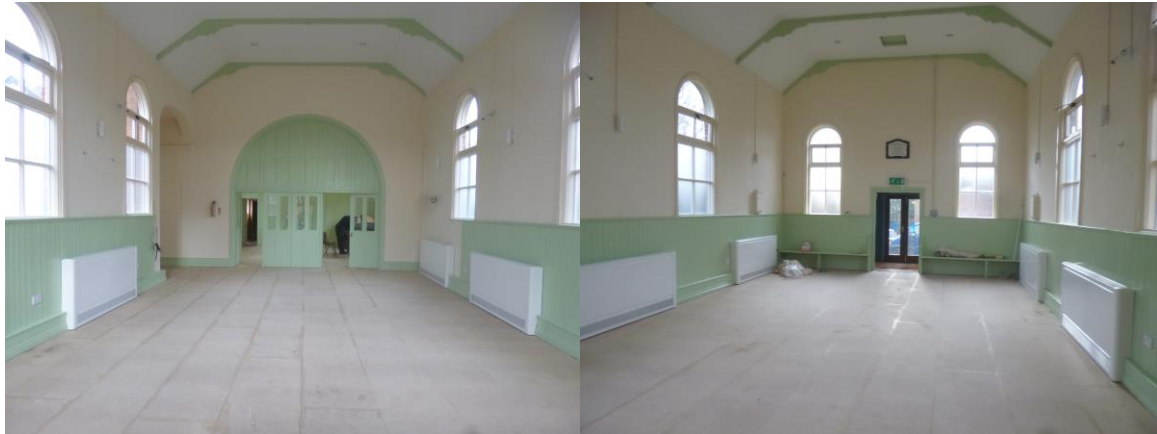
After the scaffolding was removed in mid November work started on preparing the floor for carpet laying. It was discovered that the wood block floor (which dated back to the early 20<sup>th</sup> century or earlier) was severely infected with dry rot. A decision was taken to remove the wood blocks and lay a new insulated chipboard floor – an unforeseen additional piece of work, but an essential one. At this stage the screen was also completed with two pairs of opening doors, allowing free access between the Church and schoolroom.
